INVESTIGATION OF FRACTURE IN THE T1 TANKER CAPITAN

MORGAN L. WILLIAMS AND MELVIN R. MEYERSON
National Bureau of Standards

SHIP STRUCTURE COMMITTEE

SEPTEMBER 27, 1949

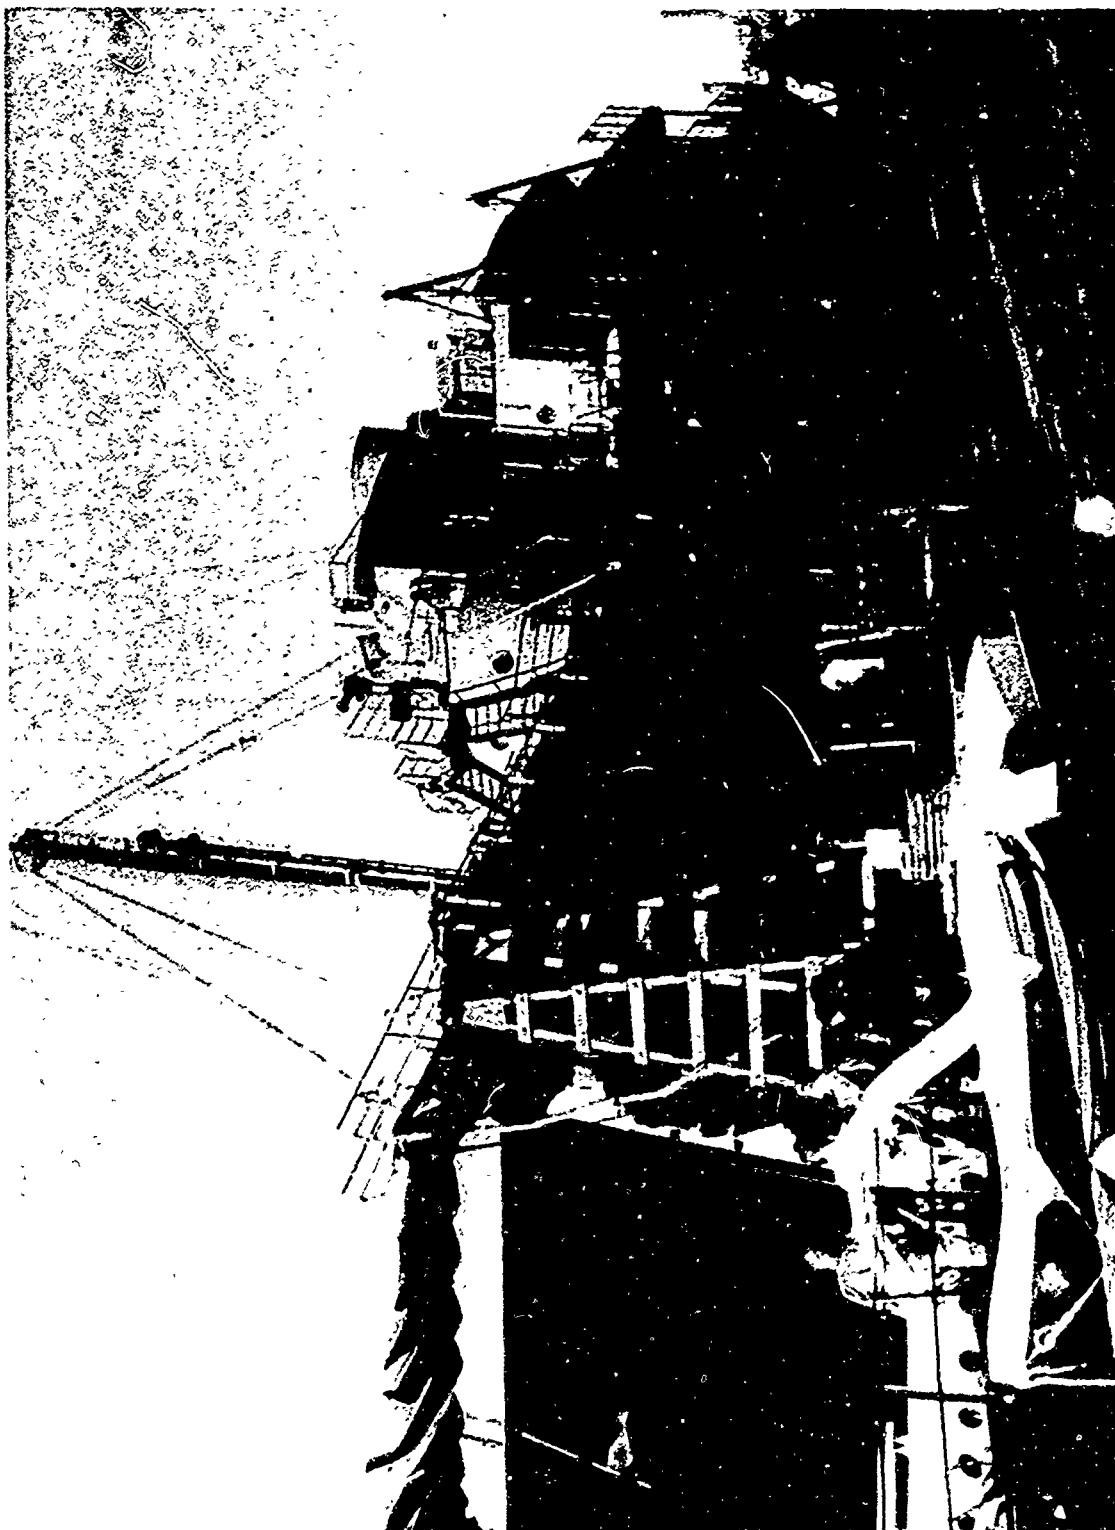
from the area aft of the fracture source in the port sheer strake and deck, and from E and F strakes in the port side shell, were selected for further examination. The locations of these samples, marked with white paint, are shown in Figure 3, which also shows a general view of the stern section. Another view, looking aft at the fracture, is shown in Figure 4.

Fig. 3. General view of stern section, port side, looking aft. Samples selected for examination are marked with white painted lines and symbols (above group of men in foreground and at top of sheer strake near fracture).

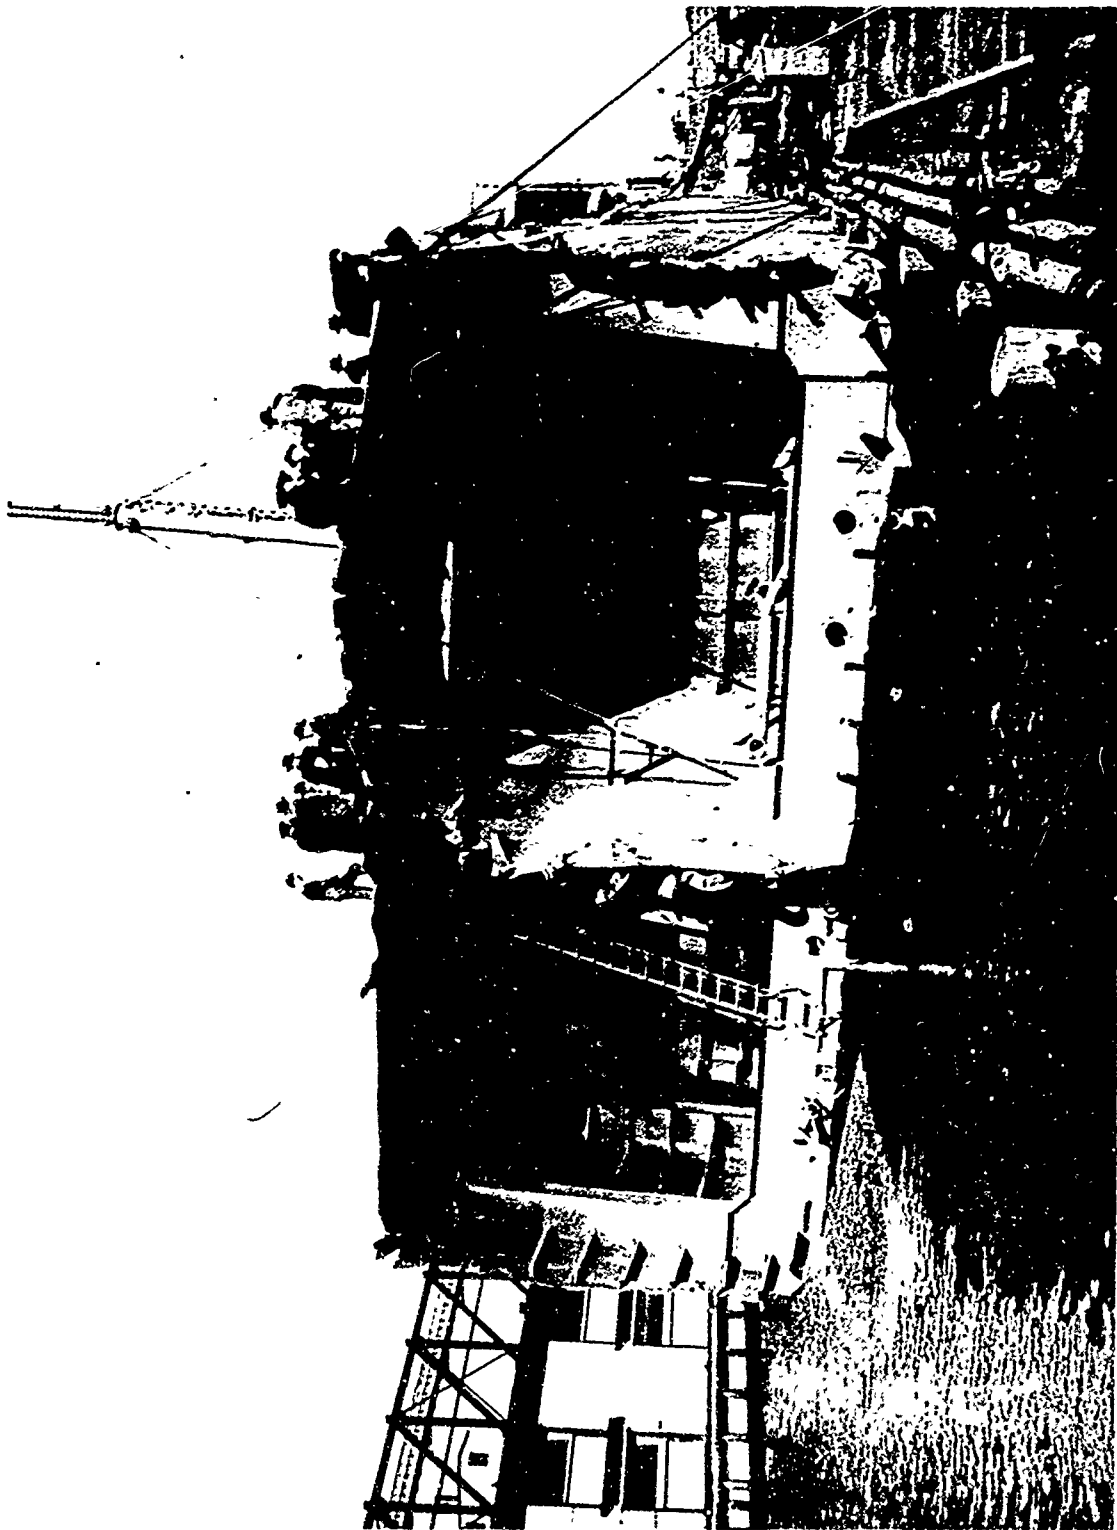
The distortion of the port center deck on the stern section (Figure 4) was of a different nature, without the reverse bends, twisting, and shear type fractures. The distortion in this area appears to be a result of battering against the superstructure in the mating position on the bow section (Figure 1). The fracture edges had been battered at several other points, as may be seen in Figures 1 through 8. Some of the plates and longitudinals, especially on the deck and the port side, had been gouged or cut by violent contact with the opposite section of the vessel. An example may be seen in the upper photograph

Fig. 4. Stern Section showing fracture just forward of frame 35. Note battered condition of plating on port side (right) and centerline bulkhead. The man leaning over the side is examining source of the fracture.

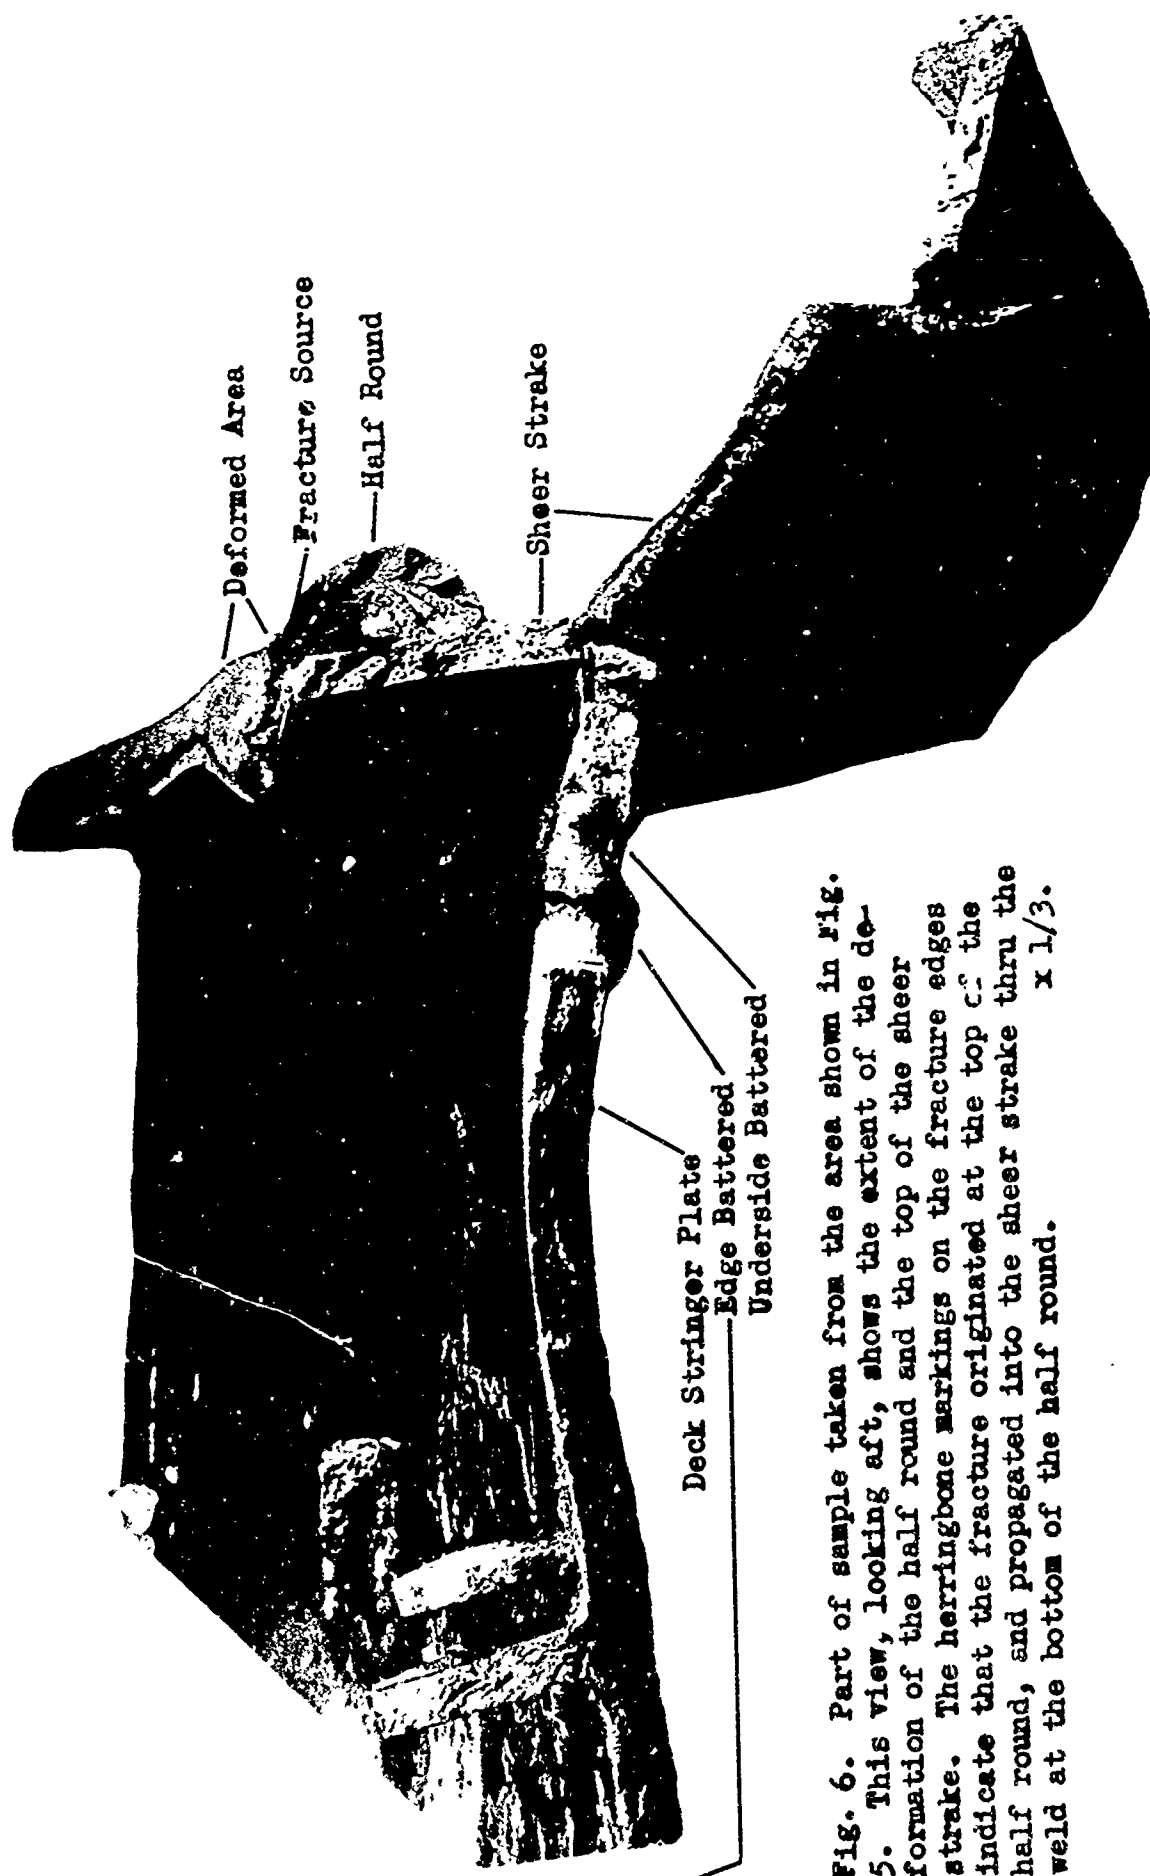
Part of the sample taken from the stern section in the region of the fracture source (Figure 5) is shown in Figure 6. After cleaning the fracture edges, the herringbone markings (which point toward the source of the fracture) were more clearly visible. These markings show that the fracture originated at the top of the half-round, propagated into the sheer strake through the small weld at the bottom of the half-round, and thence into the deck plate. The longitudinal fractures in the deck plate (Figure 6) and in the sheer strake just below the deck (Figures 5 and 6) resulted from battering after this initial fracture. A large indentation on the underside of the deck (Figure 6) and matching marks on the outboard side of the top of the chock (Figure 2) indicated that the deck of the stern section had over-ridden the bow section and had come down violently against the top of the chock. The fracture in the deck plate (Figure 6) originated at the top surface of the plate as a result of bending and did not progress completely to the bottom side of the plate. Similar bending type fractures were found along the inboard edge of the chock base (Figure 2). Two battered areas, about 14 inches apart on the fracture edge of the deck plate (Figure 6) fitted exactly with the battered parts on the bow section (Figure 2) at the inboard leg of the chock base and at the junction of the sheer strake and the lower edge of the half-round.

Specimens from the half-round were taken from the deformed area just aft of the fracture (Figures 6 and 7) and from the relatively straight undeformed area farther aft. The transition temperature for the specimens from the straight area was 100°F, indicating rather high notch sensitivity.

Fig. 6. Part of sample taken from the area shown in Fig. 5. This view, looking aft, shows the extent of the deformation of the half round and the top of the shear strake. The herringbone markings on the fracture edges indicate that the fracture originated at the top of the half round, and propagated into the shear strake thru the weld at the bottom of the half round. x 1/3.

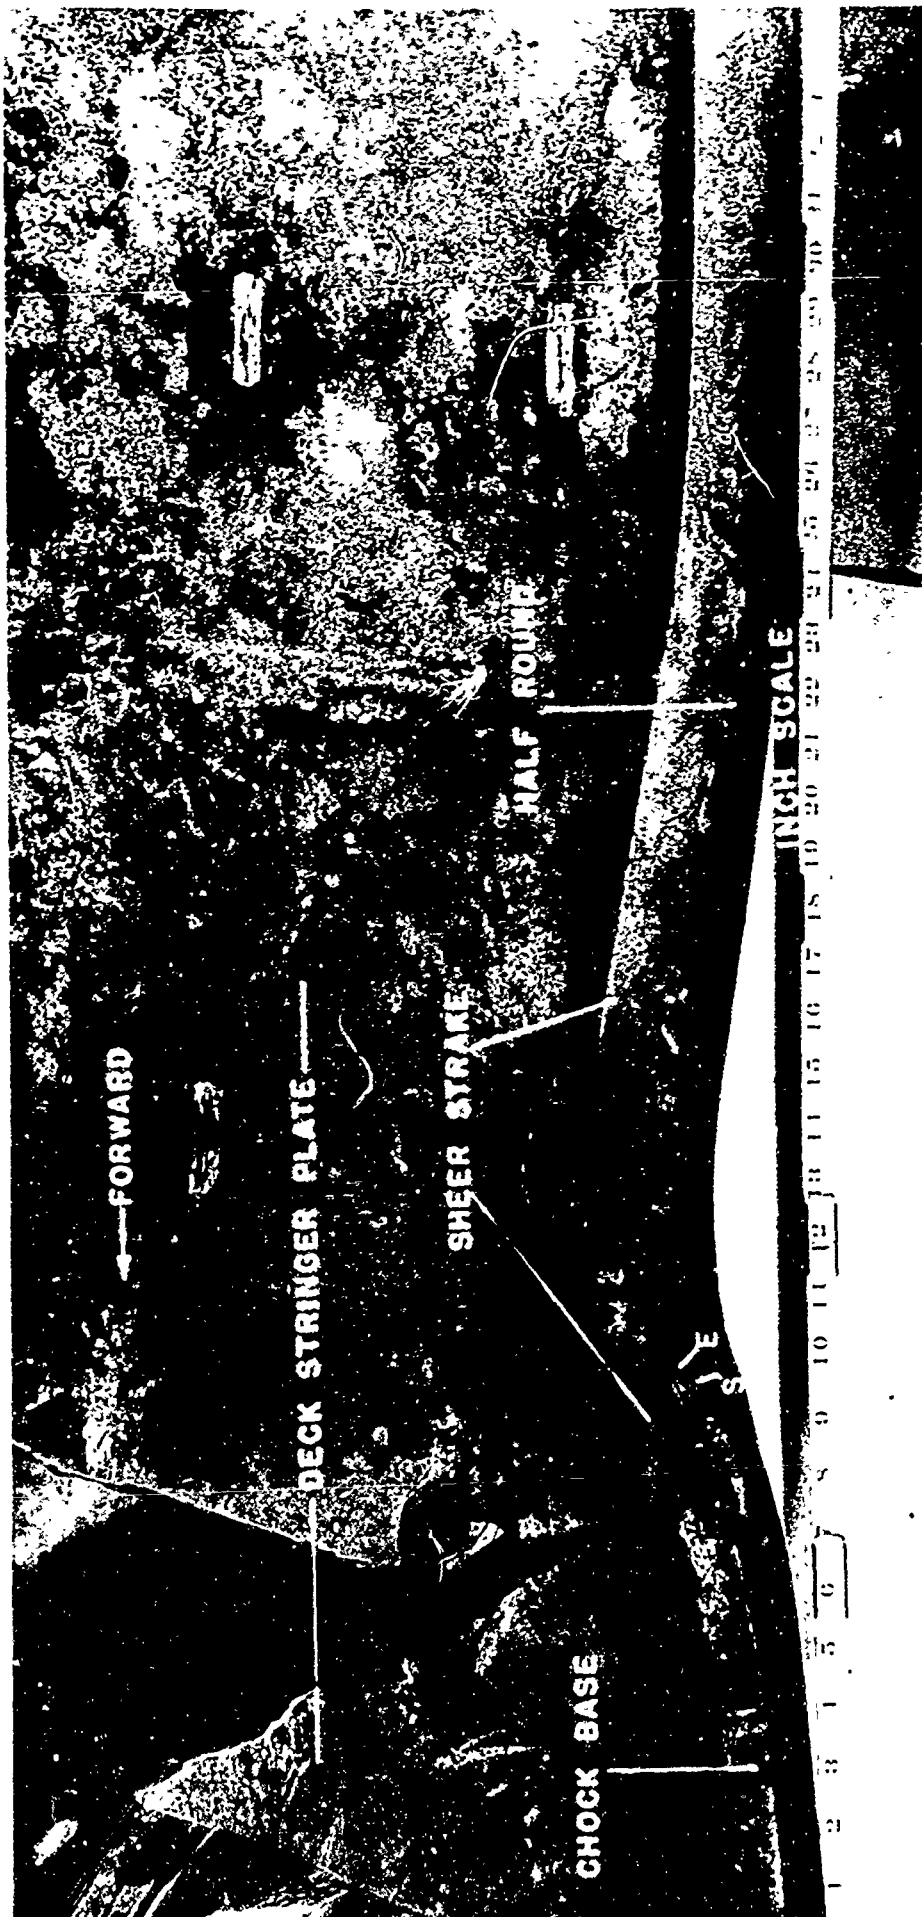
Several small brackets (Figure 7) were joined to the deck by similar small shallow welds, as shown at the left in Figure 8. These resemble the weld attaching a clip to the deck, which was one of the primary factors leading to the failure of a T2 tanker about a year previously. In that casualty, as in the CAPITAN, the fracture originated near the end of a chock base, and at a point where two welds (one of which was small and shallow) were so close together that the heat-affected zones overlapped.

Fig. 7. Fractured parts of half round fitted together, viewed from above. The smooth curvature on both sides of the fracture indicates that the deformation of the half round and the upper sheer strake occurred before the fracture. E shows longitudinal crack at top of half round. S indicates source of main fracture. The missing part of the deck stringer was bent downward - see fig. 2. x 1/4 approximately.

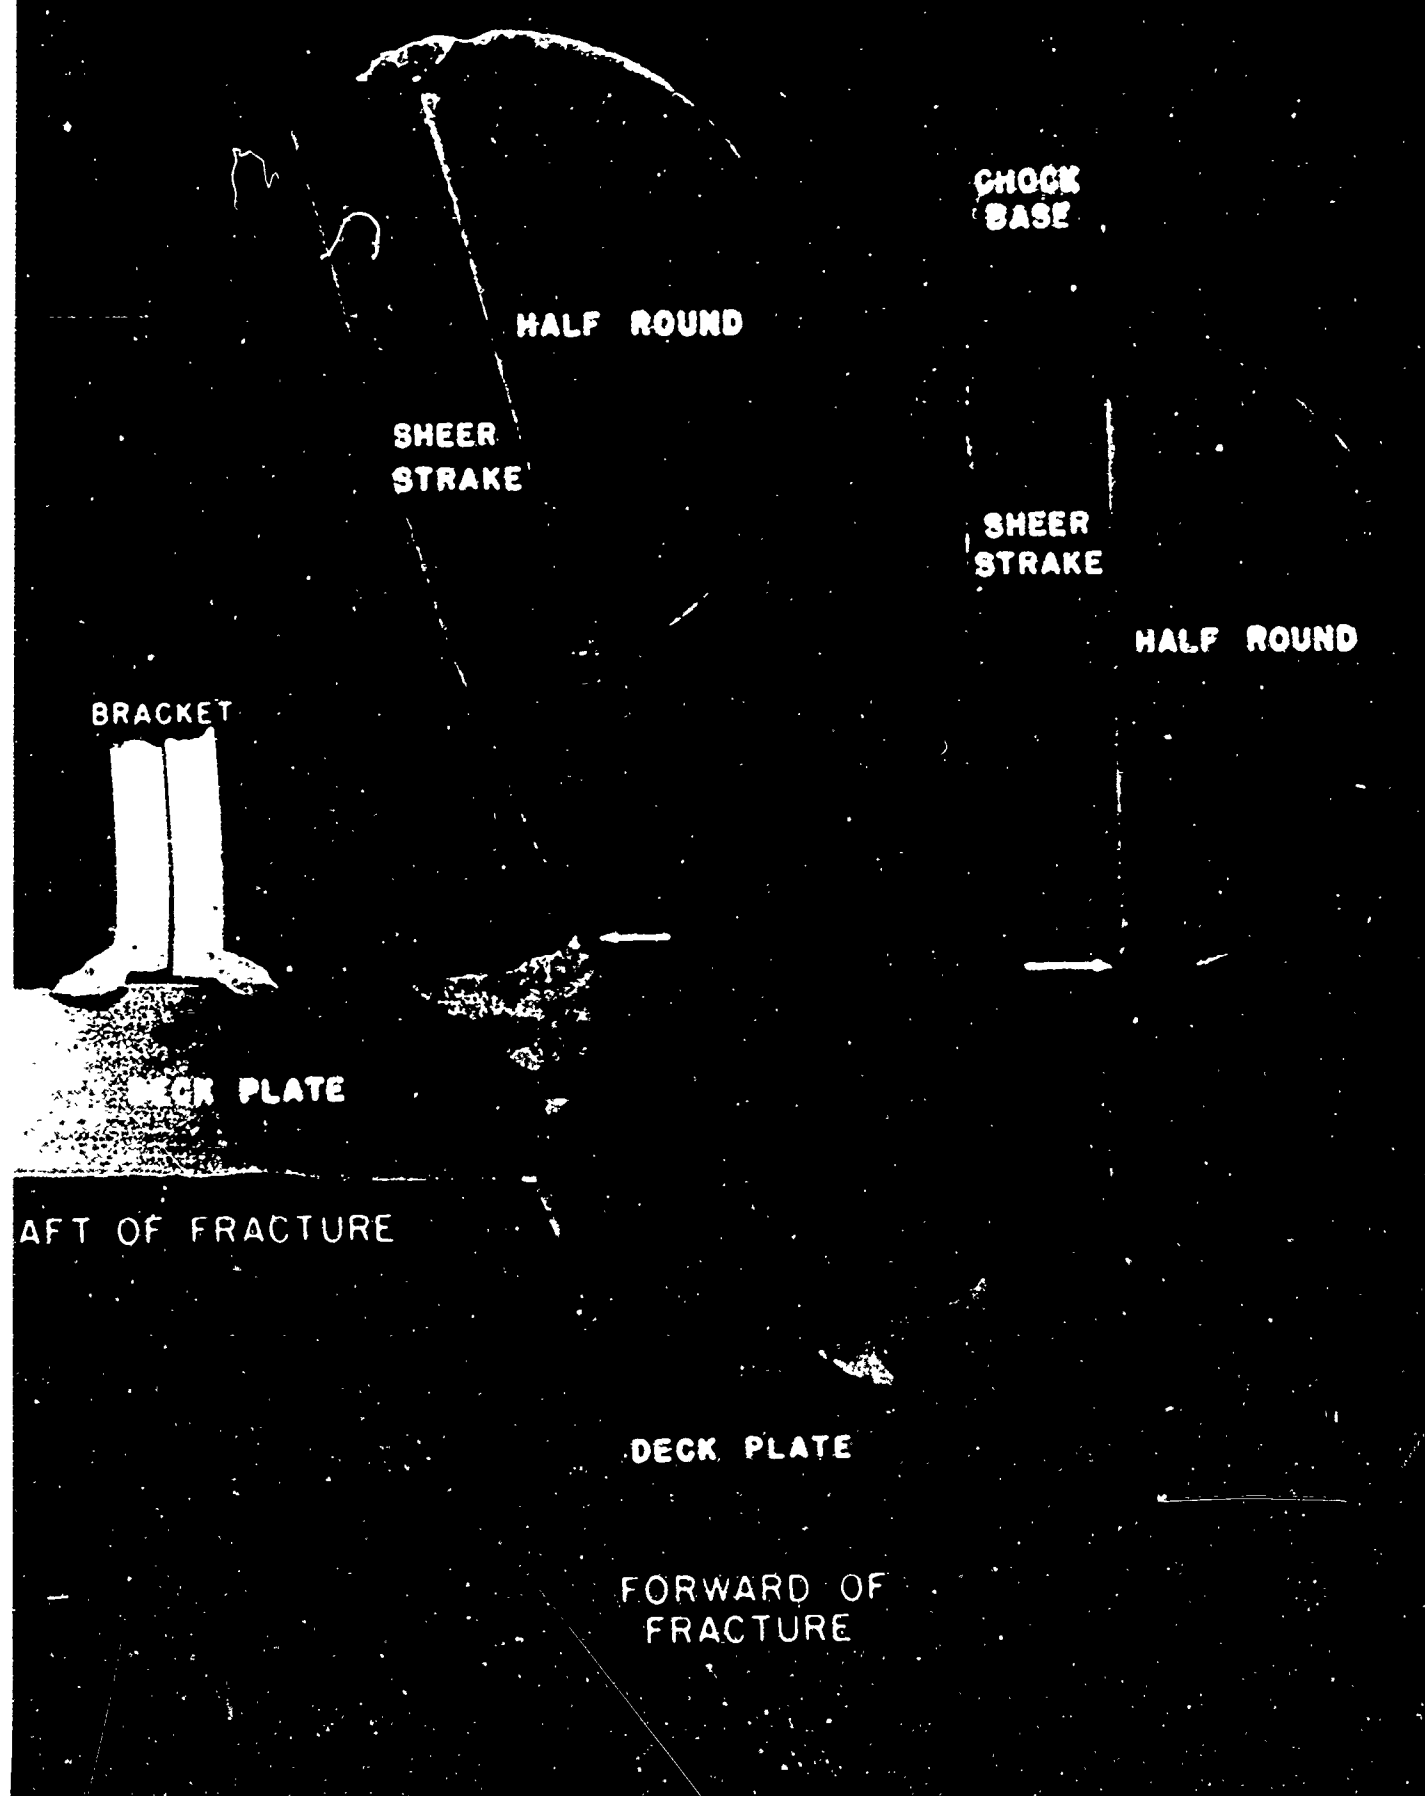
The deformation of the sheer strake is shown in Figure 8 by cross sections of the half-round, sheer strake, and deck stringer taken at locations about 9 inches forward and 4 inches aft of point S in Figure 7. The section from forward of the fracture (Figure 8, right) shows the sheer strake nearly perpendicular to the deck plate, with only slight deformation. The bottom of the half-round had separated slightly from the sheer strake, and a small crack is visible in the weld (arrow).

The section from aft of the fracture (left, Figure 8), which was taken near the point of greatest deformation, shows the sheer strake bent inboard above the deck. The deck plate was bent downward slightly at this point as a result of the battering which caused the longitudinal fracture in the sheer strake just below the deck plate (Figure 5). A small crack in the weld joining the sheer strake and the deck stringer is indicated by the arrow.

The cross sections of the deck plate, sheer strake, and half-round, shown in Figure 8, were polished and etched to determine the size and quality of the welds in the vicinity of the fracture source.

The welds joining the deck plate to the sheer strake were somewhat below average quality, since they did not penetrate the joint completely, and contained a number of slag inclusions. However, such defects are rather common

in ship construction, and these welds did not contribute to the failure.

Fig. 8. Cross sections of sheer strake, half round, and deck, port side looking aft. The extent of deformation is shown by the piece at left, taken about 4 inches aft of the fracture. Piece on right, from 9 inches forward of fracture, shows weld connecting chock base to half round and sheer strake. Arrows show small cracks in welds. x 1.

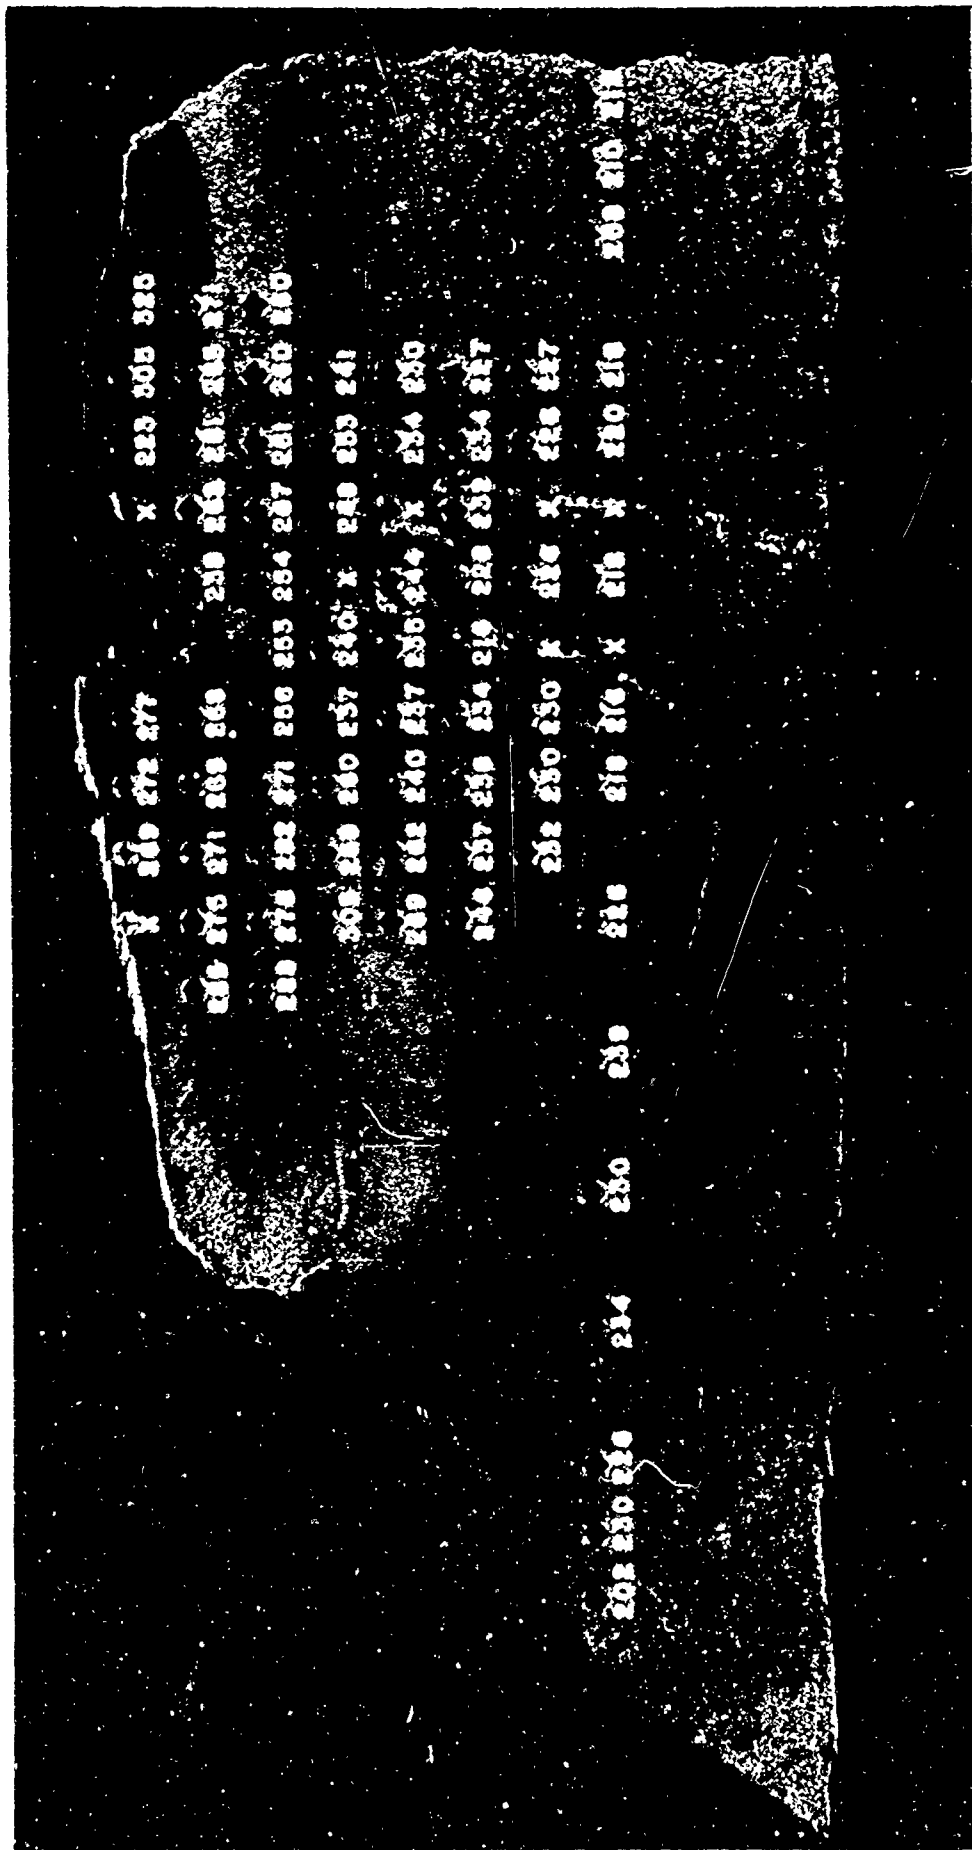
joined. The surface adjoining D-E in Figure 10 (looking in the opposite direction) is shown in Figure 11. Crack E, at the top of the specimen, originated between the weld joining the half-round to the sheer strake (top right) and the weld joining the chock base to the half-round (top left). Another small crack may be seen at the outboard (left) edge of the latter weld. The crack at the bottom in Figure 11 is a part of crack F (Figure 10) which originated between these same welds farther forward, and propagated aft and inboard overlapping but not joining crack E.

After completion of the hardness measurements shown in Figure 11 (which will be discussed later) the specimen was broken apart to expose the surfaces of the cracks. These surfaces, although somewhat corroded, showed the characteristic markings of a brittle fracture. There was no indication that the cracks had originated or propagated as a result of fatigue.

The section from near the fracture source is shown in Figure 11, with the Diamond Pyramid Hardness numbers (20 Kg load) indicated under the corresponding indentations, which were spaced 1 mm apart. (Values which were obviously erroneous due to cracks, corrosion, or unsupported edges near the indentation are indicated by the letter X). These data show that the metal of the half-round was hardened to a considerable degree in the heat-affected zones (lighter areas) under the two welds at the top, and that this hardening extended for some distance from the welds. The effect of the overlapping heat-affected zones could not be determined on this sample because of the cracking and

corrosion in this area. The hardness number 238, near the top of the crack, is probably too low, since a corrosion pit was found immediately under the indentation when the specimen was broken for examination of the crack.

The section from the top of the half-round near the fracture source (Figure 11) was considerably harder, even at some distance from the welds, than the corresponding areas on the sections from forward and aft of the fracture (Table I). This indicates that the area near the fracture source was very severely deformed, probably as a result of the restraint imposed by the chock base.

Fig. 11. Hardness impressions and cracks in section from top of half round. (Surface adjoining D in Fig. 10). Vickers Diamond Hardness numbers (20 Kg load) are shown under the corresponding impressions. The crack at the top of the specimen (crack E in Fig. 10) started in the overlapping heat affected zones between two weld beads.
